## Temperature & Vibration Testing on Zafety Lug Lock

A Report to: **TAFCAN Consulting Ltd.**  
2107 Pinevalley Crescent  
Oakville, Ontario  
L6H 6L8

Report Number: 08-03-C0185  
3 Pages, 1 Appendix

Date: July 10, 2008

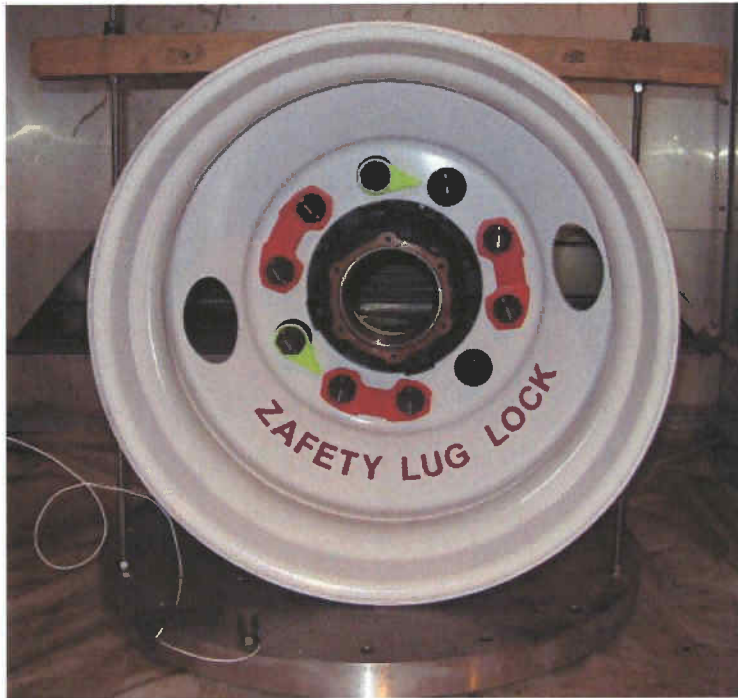
Figure 1A: Vertical vibration test set-up at 25 °C

The vibration tests were performed on the vertical table of the Thermotron DS640 vibration test system. The wheel was attached to the vibration platform with its vertical axis parallel to the vibration platform's thrust direction for vibration testing in the vertical direction (Z) as shown in Appendix A, Figure 1A and 2A.

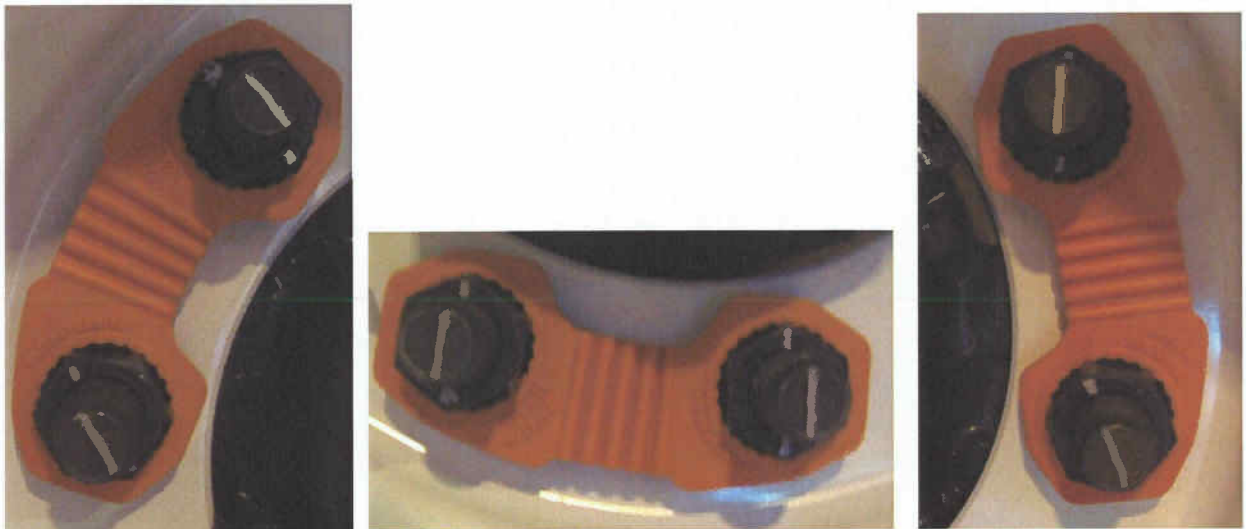
Figure 2A: Photos of Zafety Lug Lock prior to vibration test at 25 °C

The vibration test was performed in sequence listed in Table 1. On completion of the vibration testing at 25 °C, a posttest visual inspection indicated that the Zafety Lug Lock did not sustain any external damages or physical degradation and no evidence of any looseness.

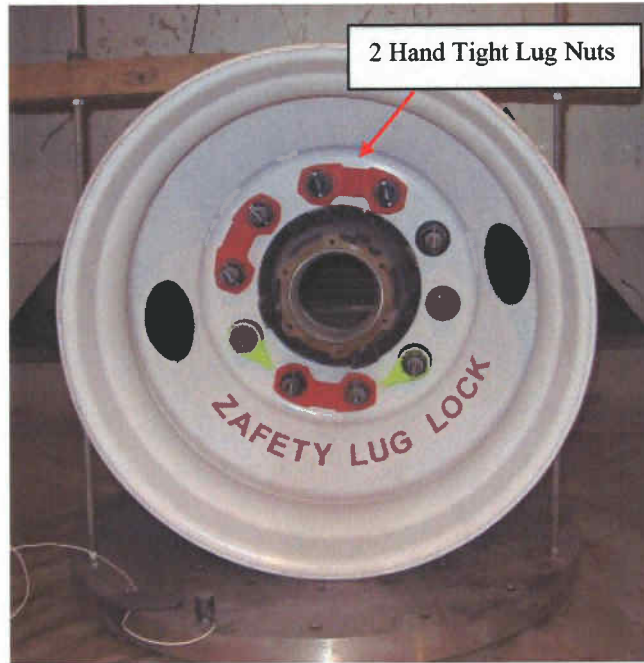
Figure 3A: Vertical vibration test set-up for 55 °C and -40 °C

Prior to the vibration test conducted at +50 °C and -40 °C, the representative installed two lug nuts with hand tight onto the top position wheel studs then inserted a Zefety Lug Lock onto them, as shown in Appendix A, Figure 3A.

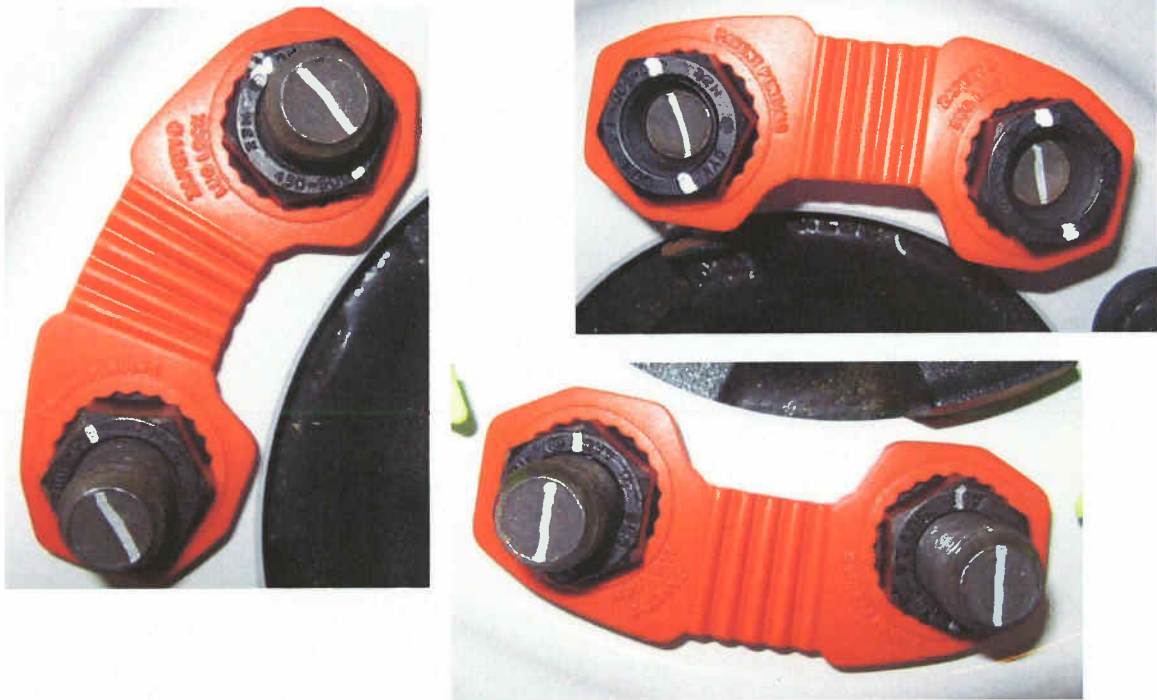
Figure 4A: Photos of Zafety Lug lock prior to vibration test at 55 °C

Again, upon completion of the vibration testing at each temperature level of +55 °C and -40 °C, a posttest visual inspection indicated that the Zafety Lug Lock did not sustain any external damages or physical degradation and no evidence of any looseness of the lug nuts.

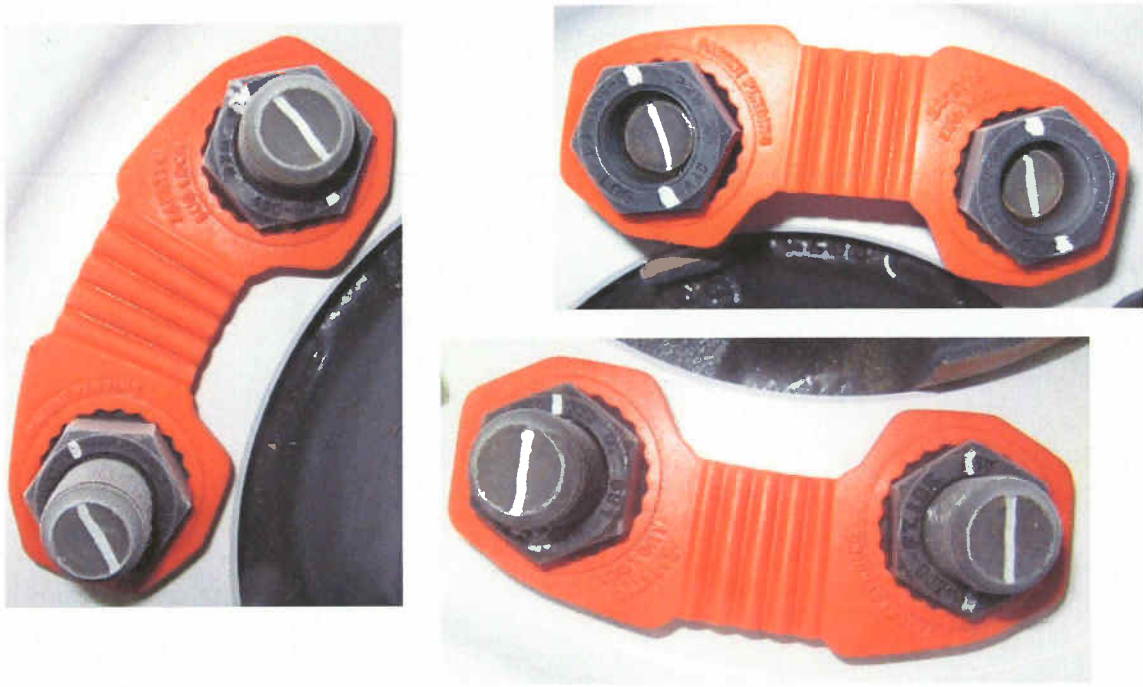
Figure 5A: Photos of Zafety Lug lock after vibration test at -40 °C

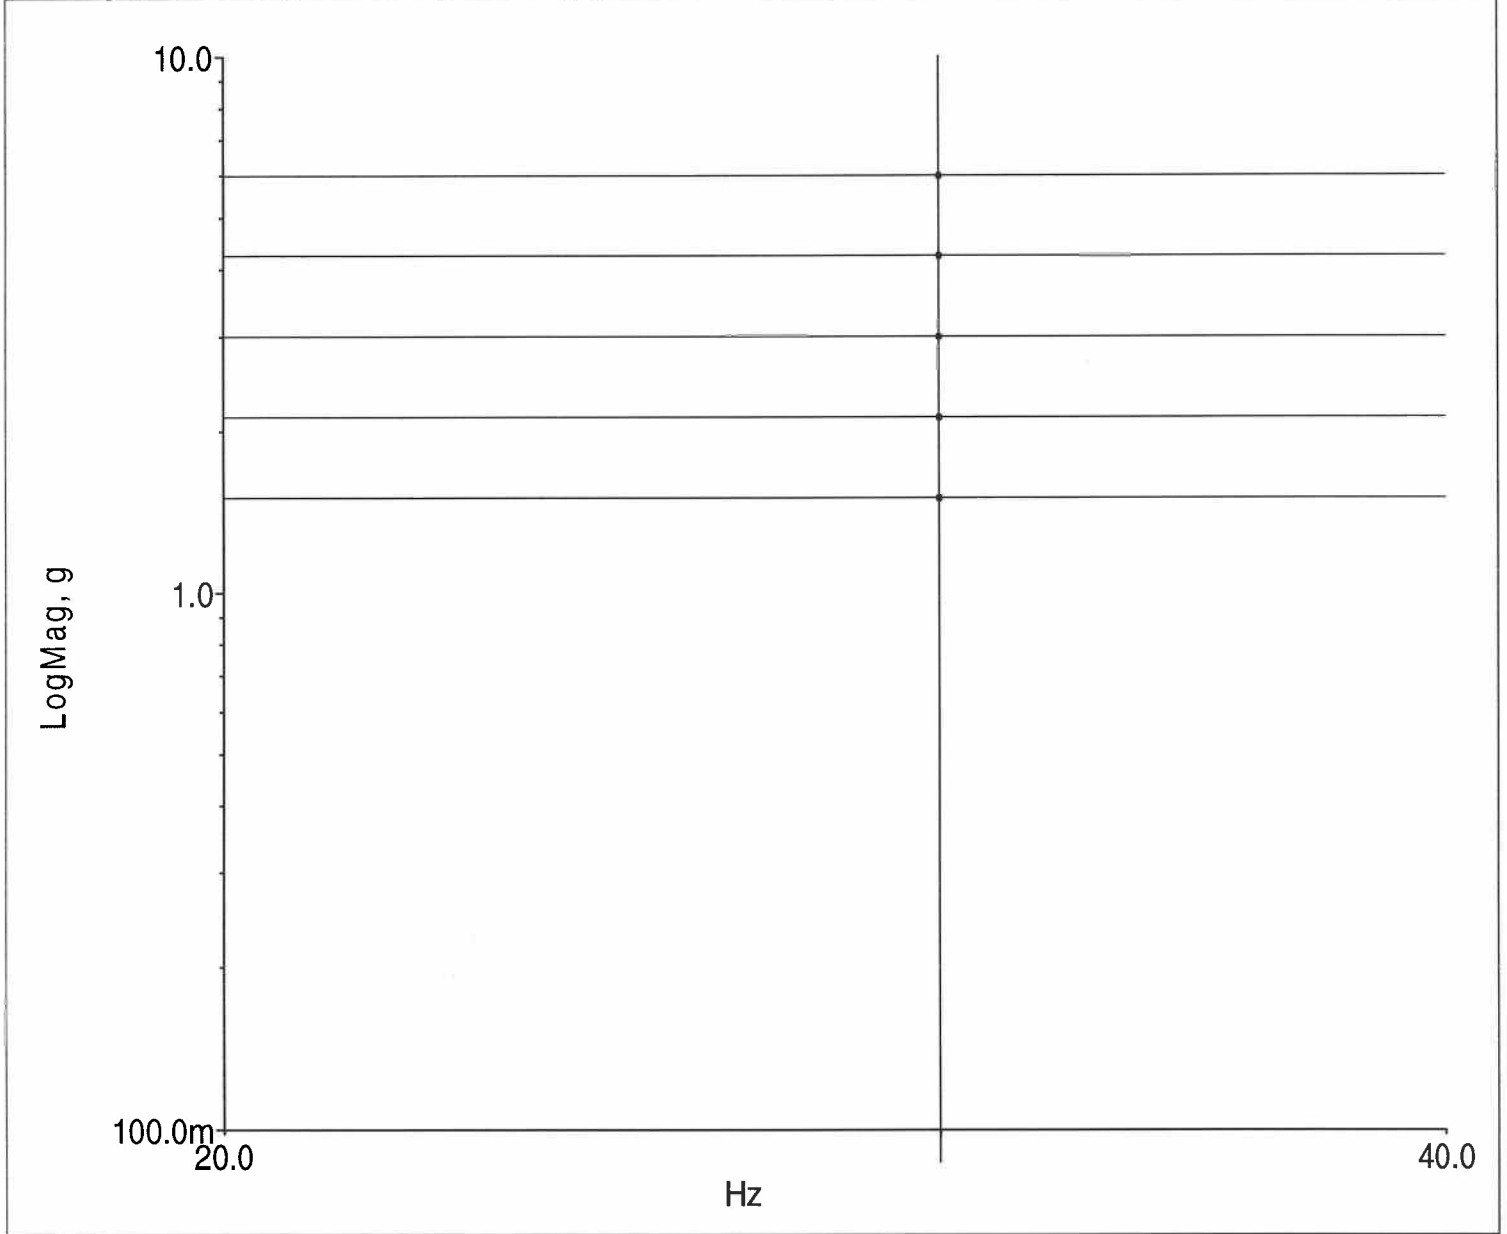
FIGURE 1B

**Bodycote Testing Group**  
**Vibration Testing for TAFCAN**  
**Dwell at 30 Hz and 3 g's for 2 hrs at 25 C**  
**BTG Sample No. 08-03-C0185-1**

Accel: 3.0059 g  
Displ: 0.06532 in p-p  
Freq: 30.00 Hz

Drive: 0.1696 V-pk  
Total Time: 02:00:19  
Status: Ready

Test started: 10:17:54 AM 7/4/2008  
Test stopped: 12:18:17 PM 7/4/2008  
Safety Lug Lock

The vibration controller generated plots for the vibration tests are shown in Appendix B, Figures 1B to 3B.
