Temperature and Vibration Testing on Safety Lug Lock

Report No.: 09-03-C0175
4 Pages, 2 Appendices

Date: August 18, 2009

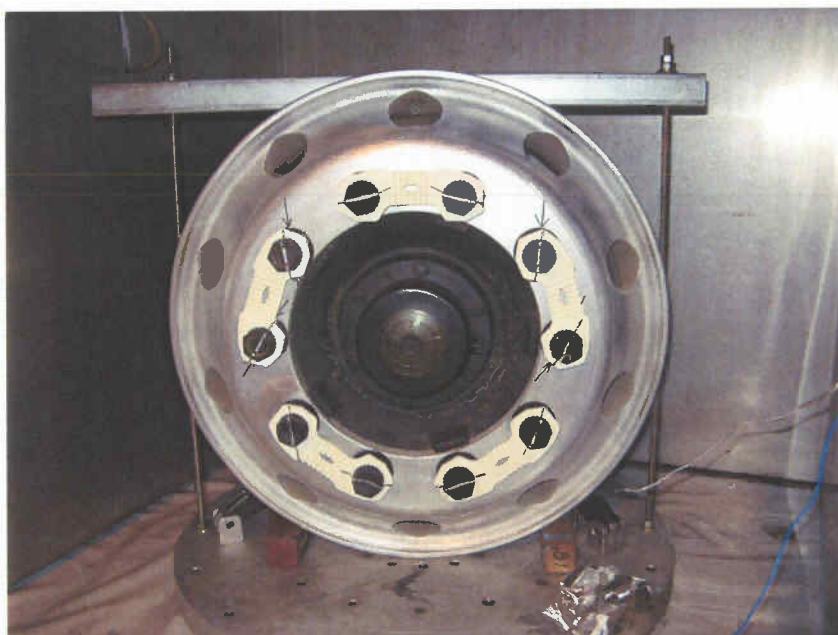
Vibration test set-up inside the *THERMOTRON* chamber (26 in. Alloy Rim)

The vibration at temperature tests were performed on a vertical motion *THERMOTRON DS-640* shaker table situated inside a *THERMOTRON* thermal chamber. The wheel was attached to the vibration platform with its vertical axis parallel to the vibration platform's thrust direction. Hence, the sample was vibrated in the vertical direction (Z axis), as shown in Appendix A, Figure 1A and Figure 5A. One accelerometer which provided the control signal was attached to the vibration platform in thrust direction.

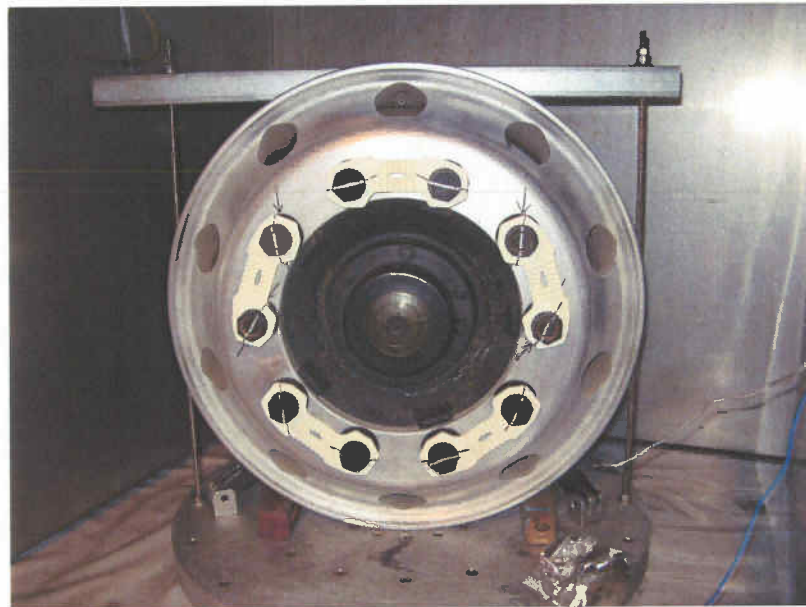
Figure 3A

The 26 in. Alloy Rim after vibration testing at 120°C

Post-test visual inspections indicated the Zafety Lug Locks did not sustain any external damages or physical degradation. Further, no looseness of any lug nuts was indicated. Photographic documentation is provided in Appendix A, as follows:

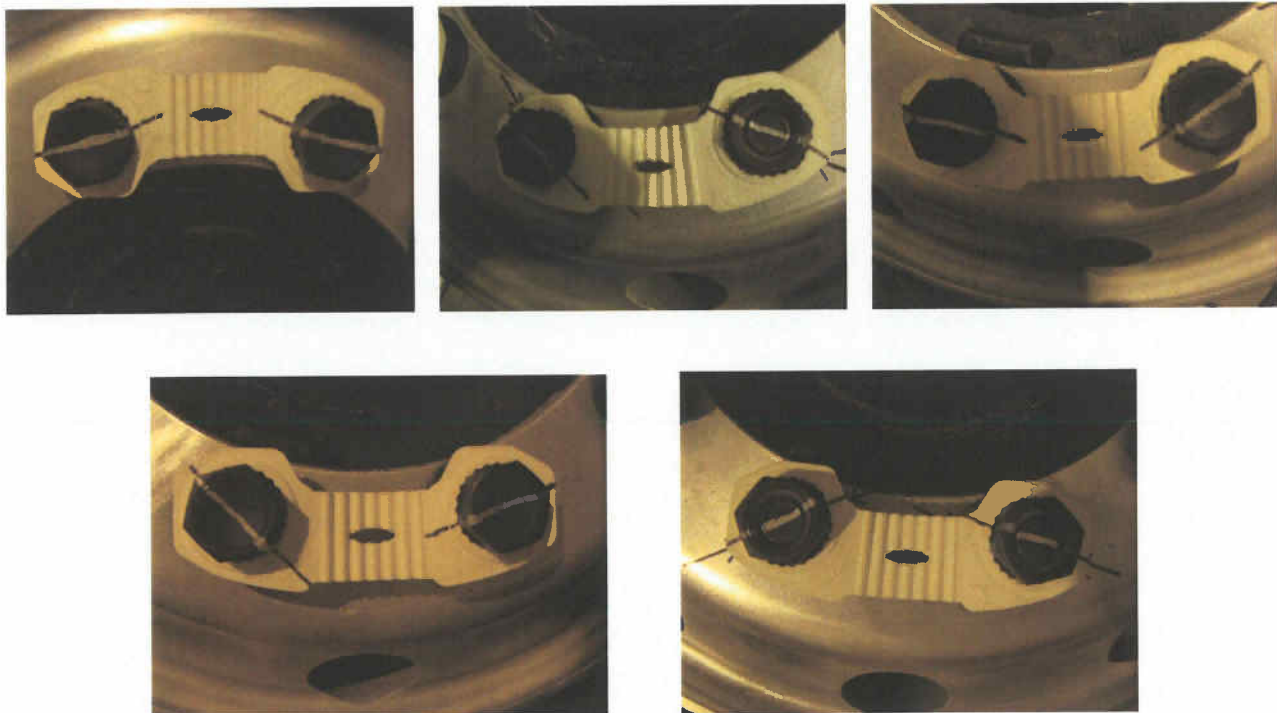
Figure 4A

The various lug nuts and Safety Lug Lock units, indicating the position of the lug nuts after testing at 120°C

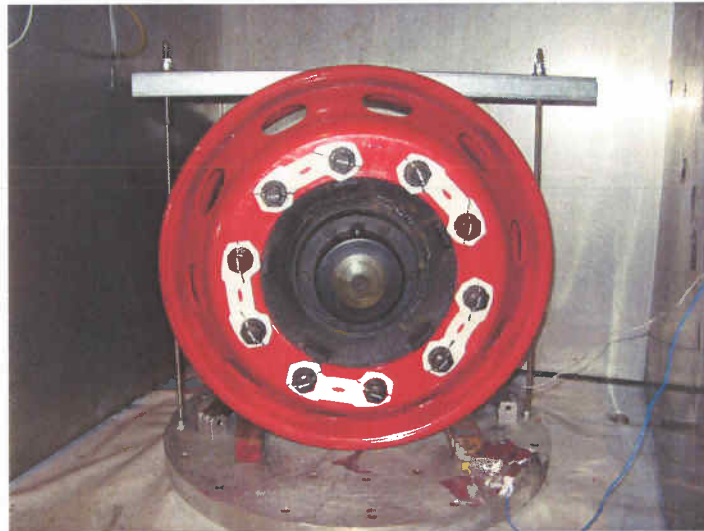
Figure 5A

Vibration test set-up inside the *THERMOTRON* chamber (26 in. Steel Rim)

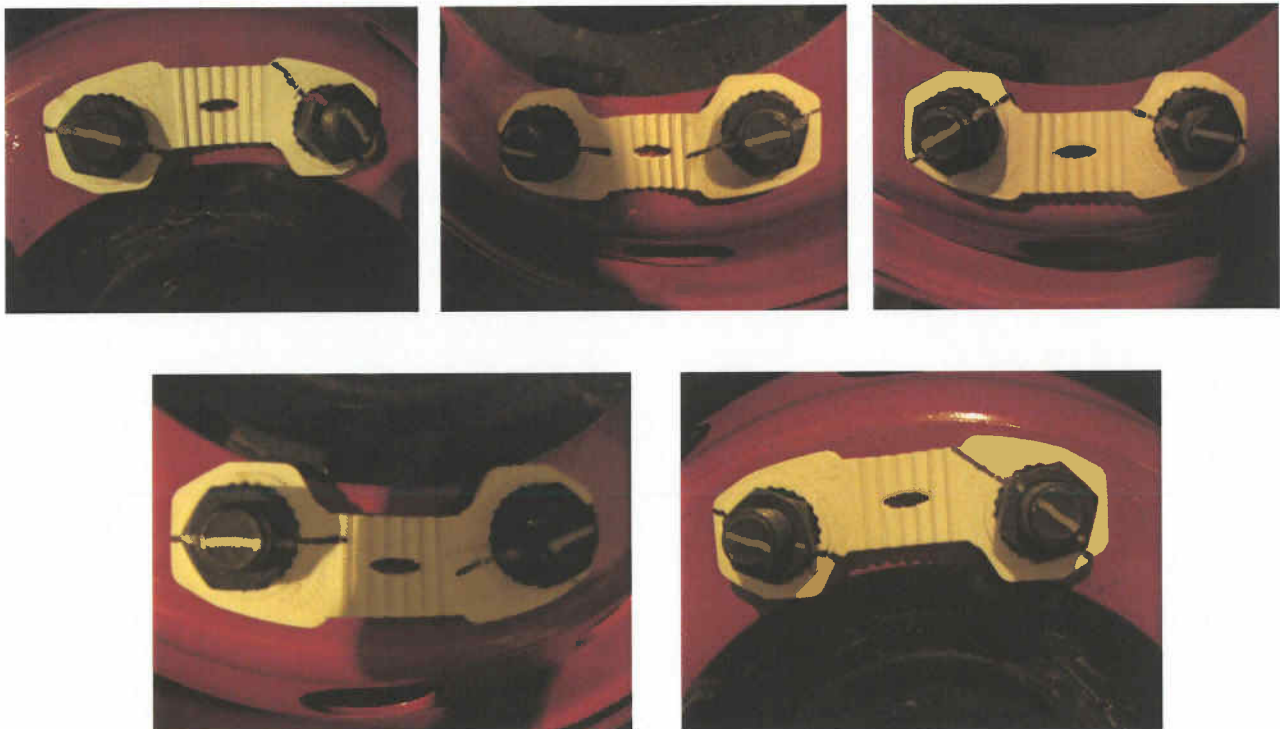
Figure 6A

The various lug nuts and Safety Lug Lock units, indicating the position of the lug nuts prior to testing

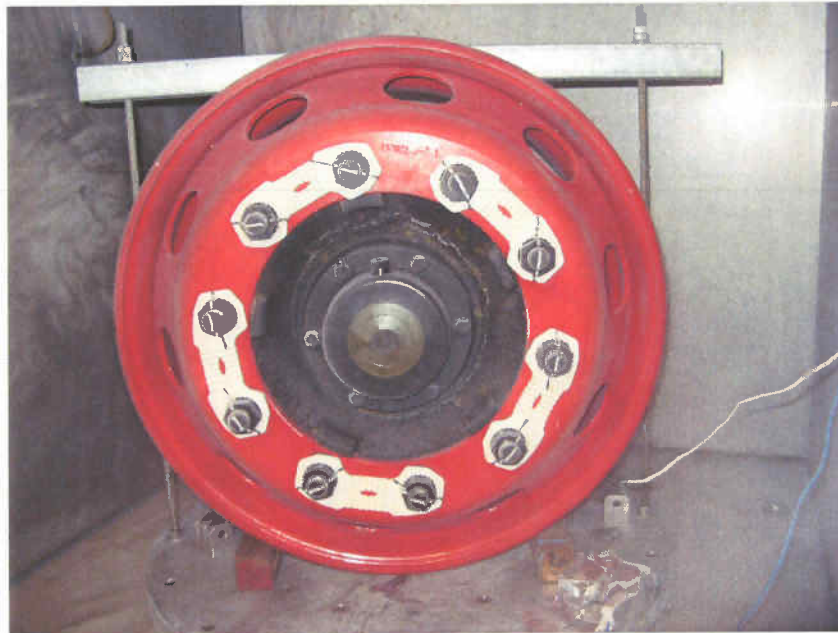
Figure 7A

The 26 in. Steel Rim after vibration testing at -40°C
