Temperature & Vibration Testing on Zafety Lug Lock

A Report to: **TAFCAN** Consulting Ltd.

Report Number: 08-03-C0185

Date: July 10, 2008

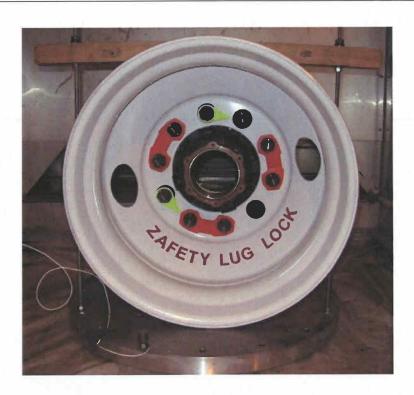
Figure 1A: Vertical vibration test set-up at 25 °C

The vibration tests were performed on the vertical table of the Thermotron DS640 vibration test system. The wheel was attached to the vibration platform with its vertical axis parallel to the vibration platform's thrust direction for vibration testing in the vertical direction (Z) as shown in Appendix A, Figure 1A and 2A.

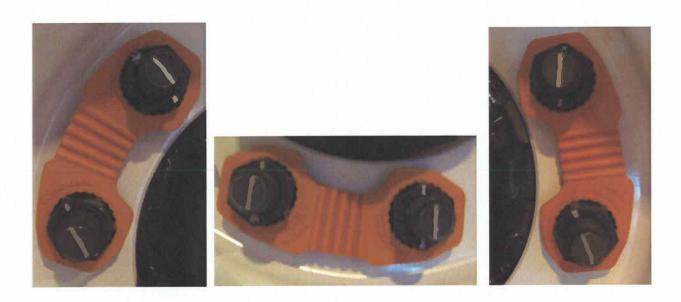
Figure 2A: Photos of Zafety Lug Lock prior to vibration test at 25 °C

The vibration test was performed in sequence listed in Table 1. On completion of the vibration testing at 25 °C, a posttest visual inspection indicated that the Zafety Lug Lock did not sustain any external damages or physical degradation and no evidence of any looseness.

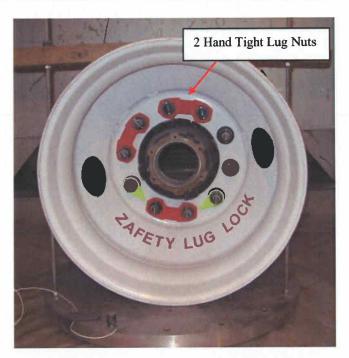
Figure 3A: Vertical vibration test set-up for 55 $^{\circ}\text{C}$ and -40 $^{\circ}\text{C}$

Prior to the vibration test conducted at +50 °C and -40 °C, the representative installed two lug nuts with hand tight onto the top position wheel studs then inserted a Zefety Lug Lock onto them, as shown in Appendix A, Figure 3A.

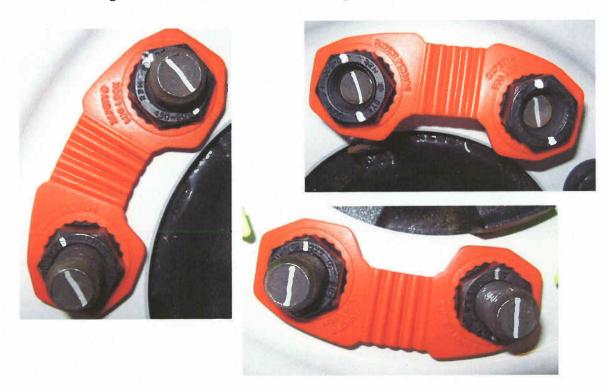
Figure 4A: Photos of Zafety Lug lock prior to vibration test at $55\,^{\circ}\mathrm{C}$

Again, upon completion of the vibration testing at each temperature level of +55 °C and -40 °C, a posttest visual inspection indicated that the Zafety Lug Lock did not sustain any external damages or physical degradation and no evidence of any looseness of the lug nuts.

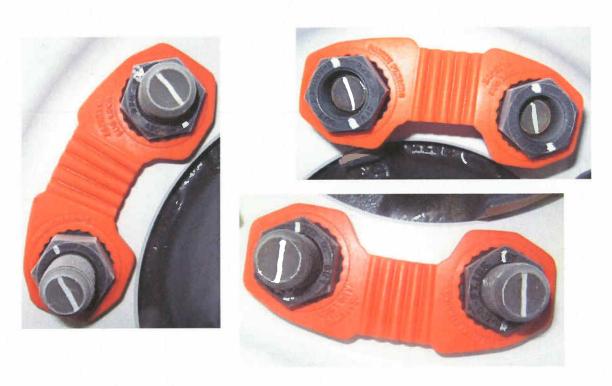
Figure 5A: Photos of Zafety Lug lock after vibration test at -40 °C

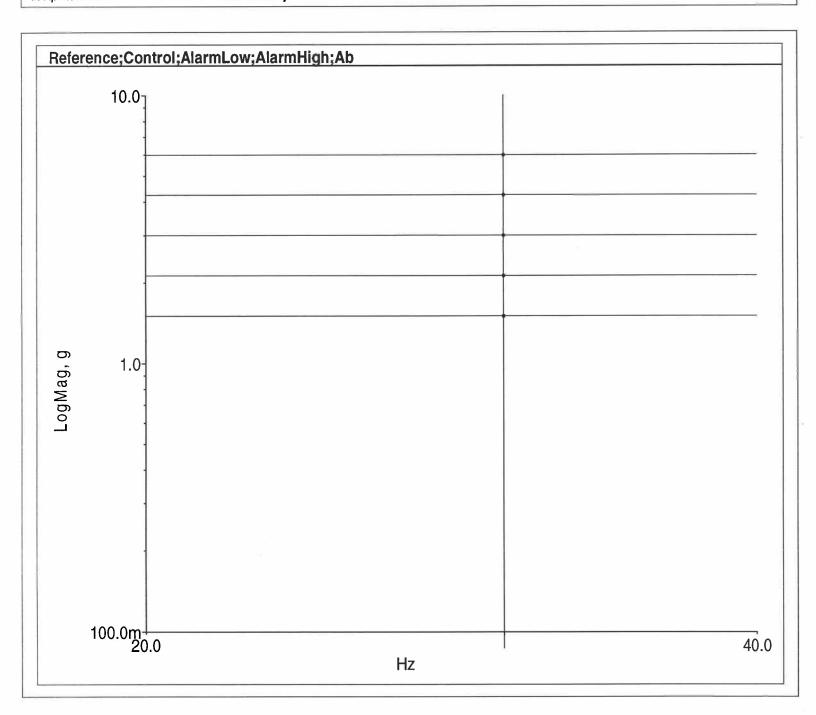
FIGURE 1B

Bodycote Testing Group Vibration Testing for TAFCAN Dwell at 30 Hz and 3 g's for 2 hrs at 25 C BTG Sample No. 08-03-C0185-1

Accel: 3.0059 g Displ: 0.06532 in p-p Freq: 30.00 Hz

Drive: 0.1696 V-pk Total Time: 02:00:19 Status: Ready

The vibration controller generated plots for the vibration tests are shown in Appendix B, Figures 1B to 3B.

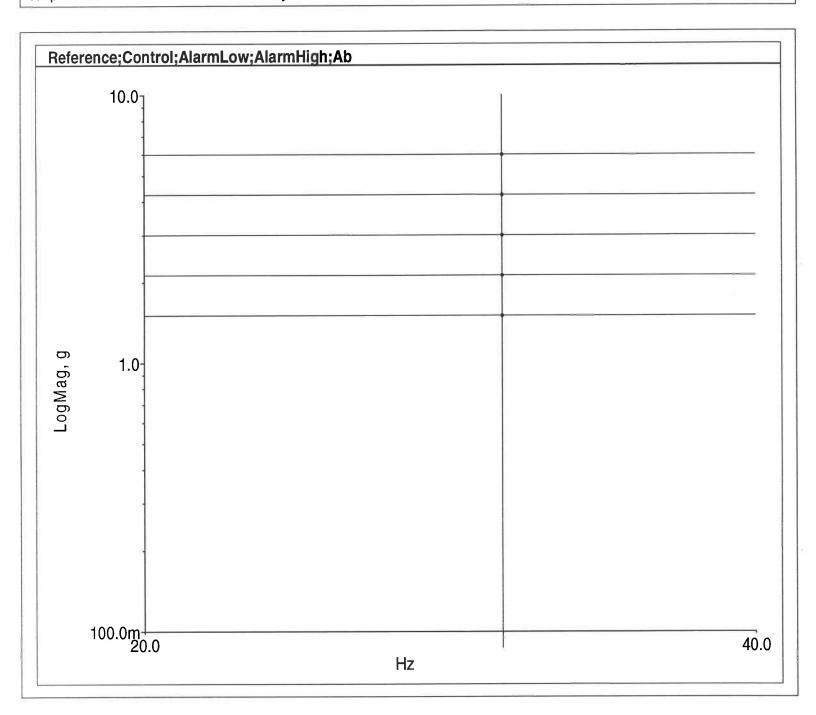
FIGURE 2B

Bodycote Testing Group Vibration Testing for TAFCAN Dwell at 30 Hz and 3 g's for 2 hrs at +50 C (+122 F) BTG Sample No. 08-03-C0185-1

Accel: 2.9985 g Displ: 0.06516 in p-p Freq: 30.00 Hz Drive: 0.1735 V-pk Total Time: 02:00:19 Status: Ready Run State: Auto Loop: Closed Checks: Enabled

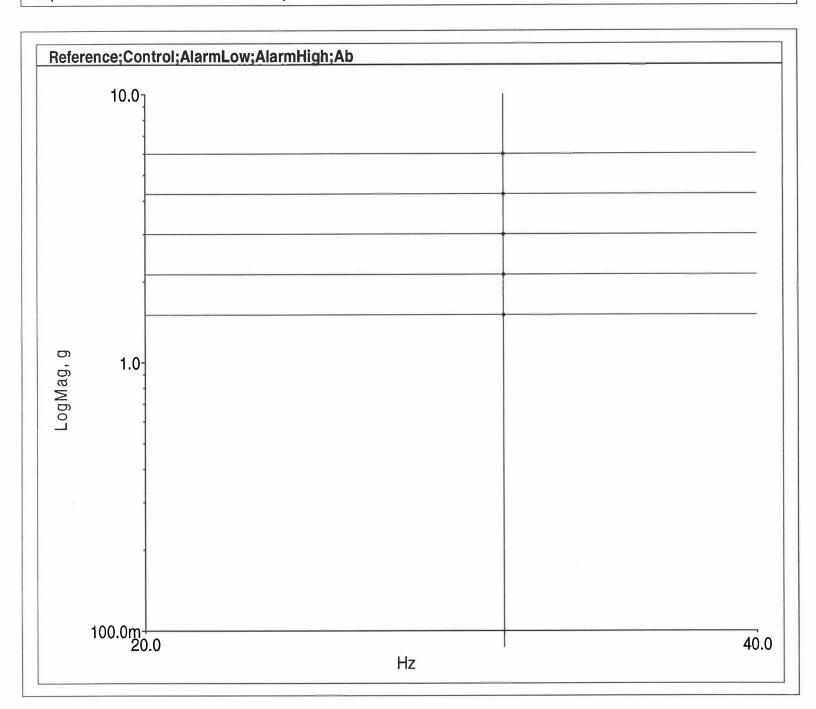
FIGURE 3B

Bodycote Testing Group Vibration Testing for TAFCAN Dwell at 30 Hz and 3 g's for 2 hrs at -40 C (-40 F) BTG Sample No. 08-03-C0185-1

Accel: 2.9941 g Displ: 0.06506 in p-p Freq: 30.00 Hz Drive: 0.1642 V-pk Total Time: 02:00:19 Status: Ready Run State: Auto Loop: Closed Checks: Enabled
