Temperature and Vibration Testing on Safety Lug Lock

A Report to:	TAFKAN Consulting Ltd. 2107 Pinevalley Crescent Oakville, ON L6H 6L8
Attention:	Mr. Taffy Davies
Telephone:	905-344-3771
Fax:	905-849-6607
Email:	tafcan@coqeco.ca
Report No.:	09-03-C0175 4 Pages, 2 Appendices
Proposal No.:	09-003-5651
Date:	August 18, 2009

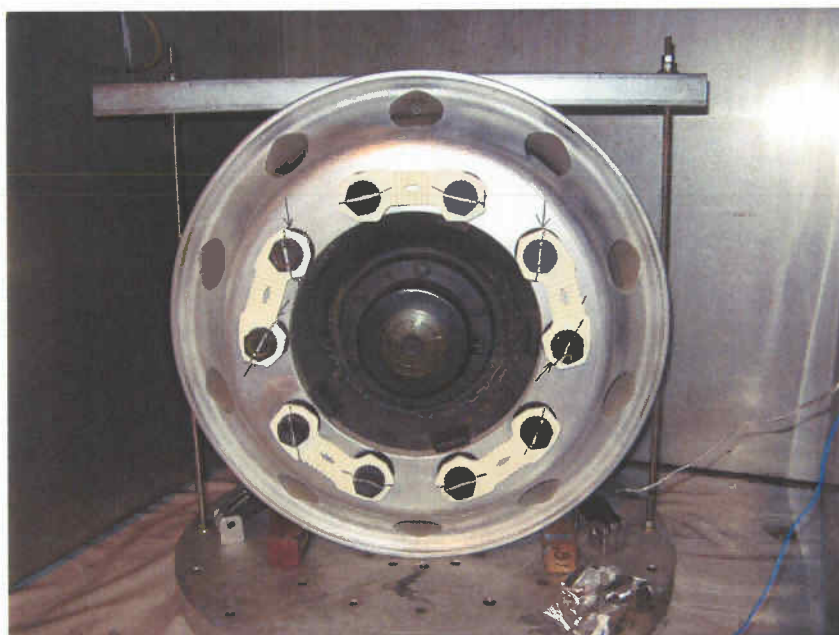
Vibration test set-up inside the *THERMOTRON* chamber (26 in. Alloy Rim)

The vibration at temperature tests were performed on a vertical motion *THERMOTRON DS-640* shaker table situated inside a *THERMOTRON* thermal chamber. The wheel was attached to the vibration platform with its vertical axis parallel to the vibration platform's thrust direction. Hence, the sample was vibrated in the vertical direction (Z axis), as shown in Appendix A, Figure 1A and Figure 5A. One accelerometer which provided the control signal was attached to the vibration platform in thrust direction.

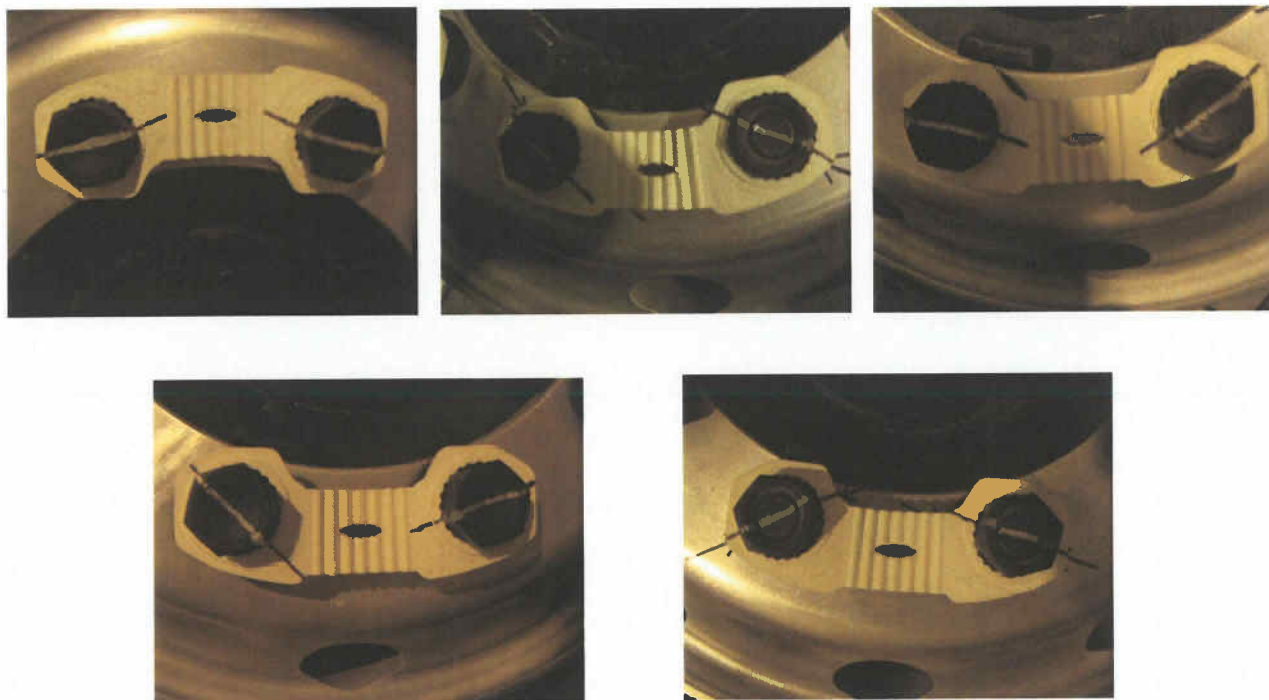
Figure 2A

The various lug nuts and Safety Lug Lock units, indicating the position of the lug nuts prior to testing

A TAFKAN representative was present to install the Safety Lug Locks onto the hand tightened lug nuts of the wheel prior to attachment to the vibration platform. All nuts were hand tightened. The position of the nuts was indicated by lines made with a permanent marker pen on the Safety Lug Locks.

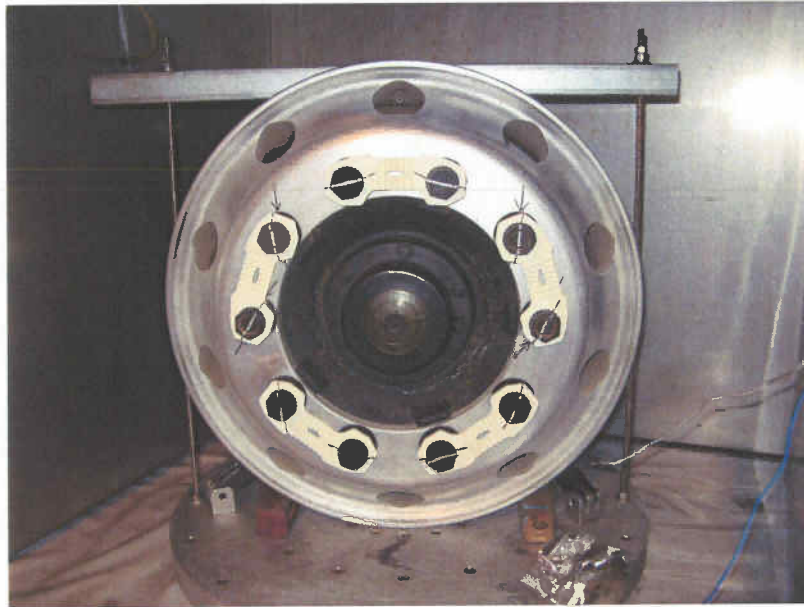
Figure 3A

The 26 in. Alloy Rim after vibration testing at 120°C

Post-test visual inspections indicated the Zafety Lug Locks did not sustain any external damages or physical degradation. Further, no looseness of any lug nuts was indicated. Photographic documentation is provided in Appendix A, as follows:

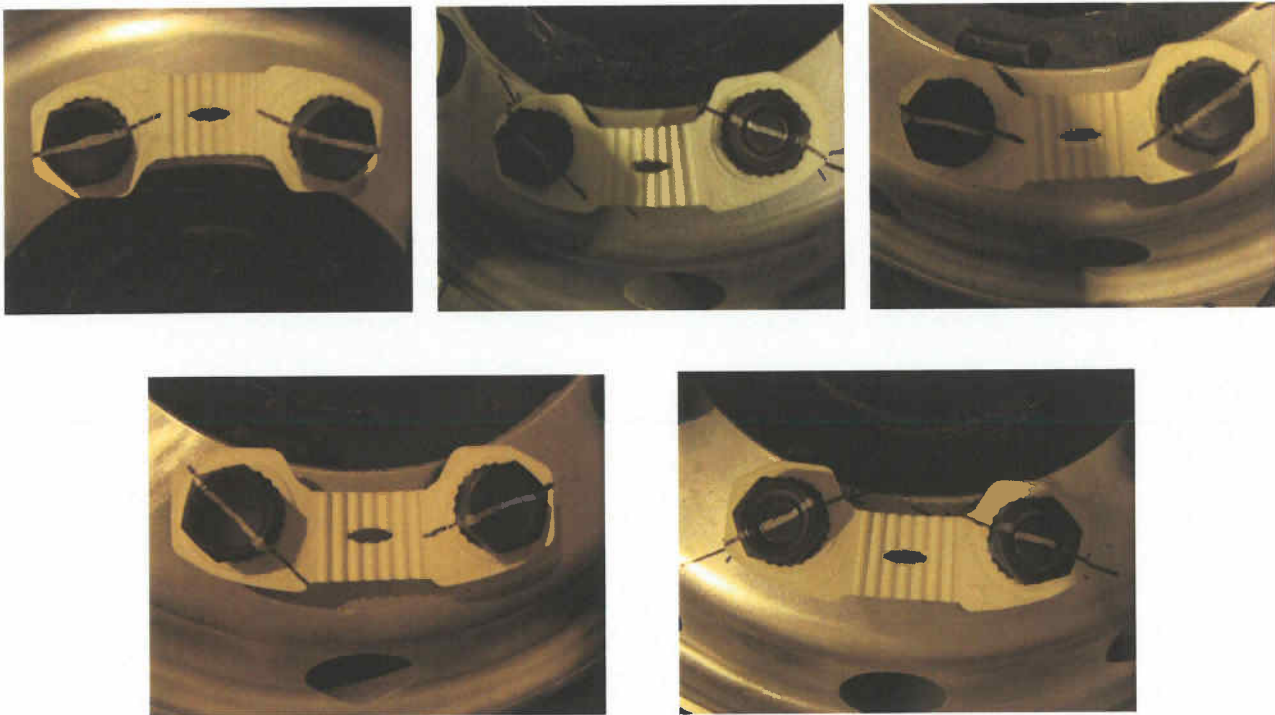
Figure 4A

The various lug nuts and Safety Lug Lock units, indicating the position of the lug nuts after testing at 120°C

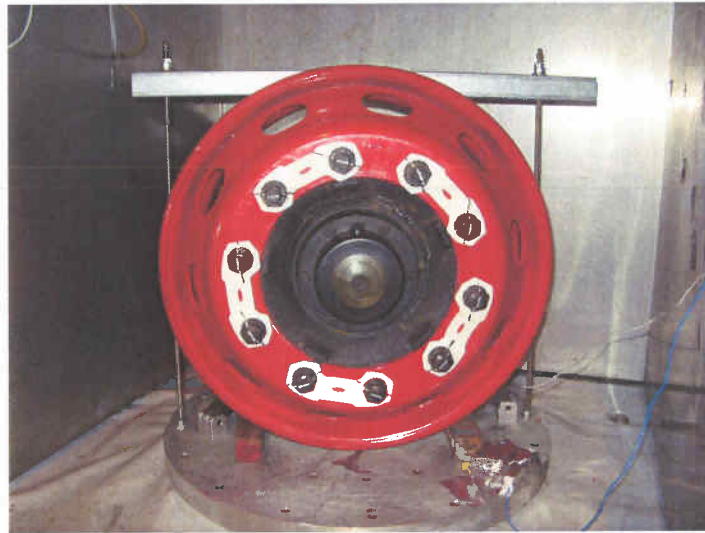
Figure 5A

Vibration test set-up inside the *THERMOTRON* chamber (26 in. Steel Rim)

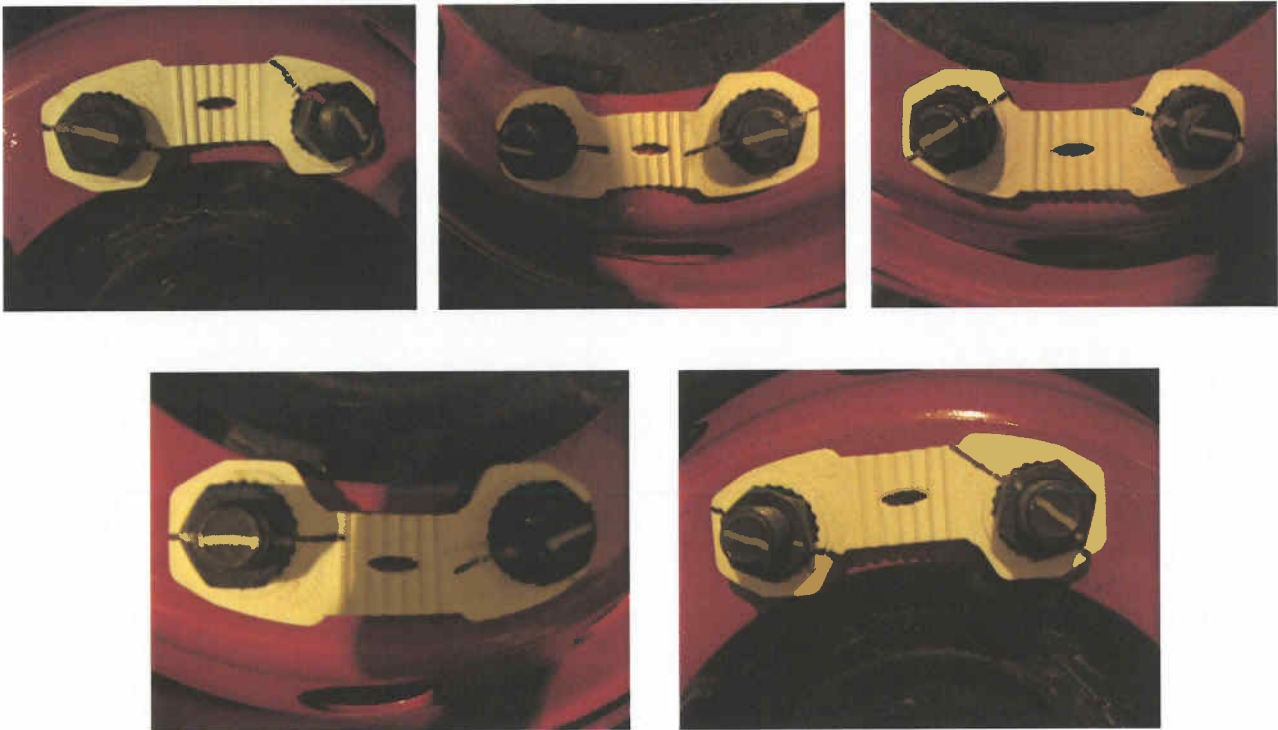
Figure 6A

The various lug nuts and Safety Lug Lock units, indicating the position of the lug nuts prior to testing

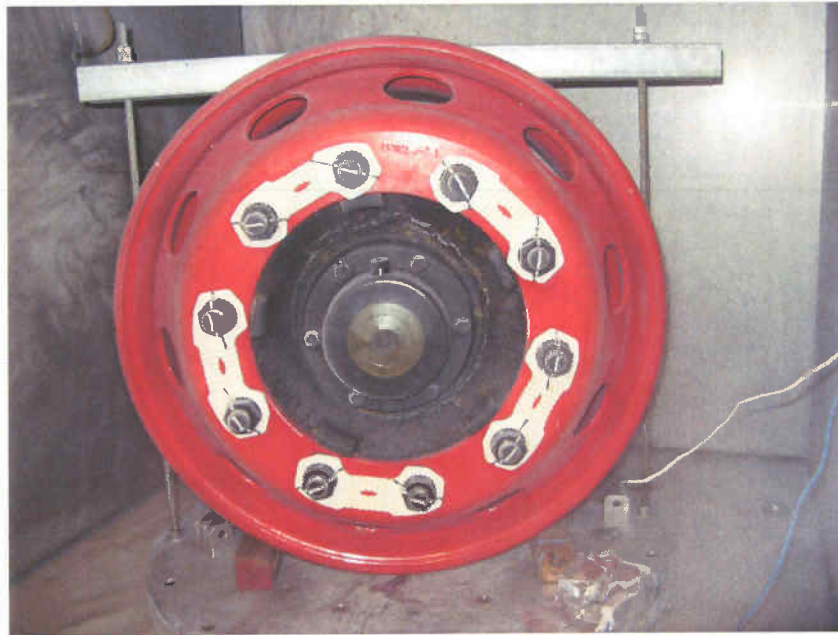
Figure 7A

The 26 in. Steel Rim after vibration testing at -40°C

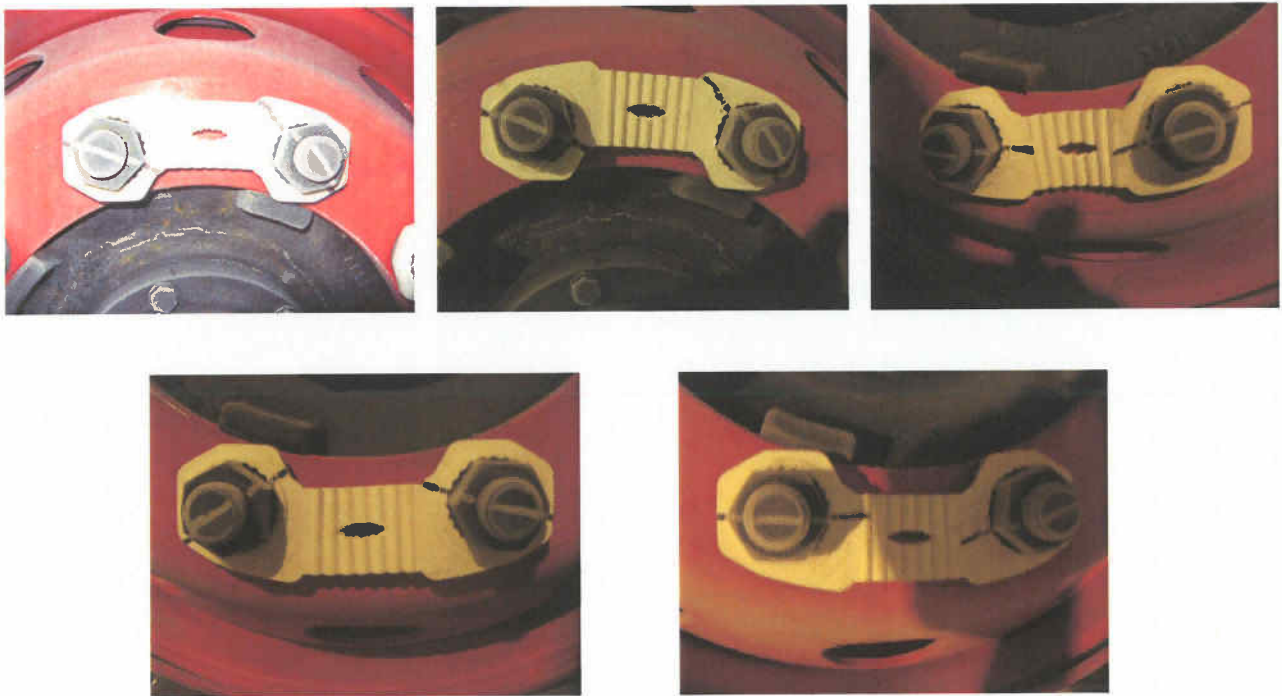
Figure 8A

The various lug nuts and Safety Lug Lock units, indicating the position of the lug nuts after testing at -40°C

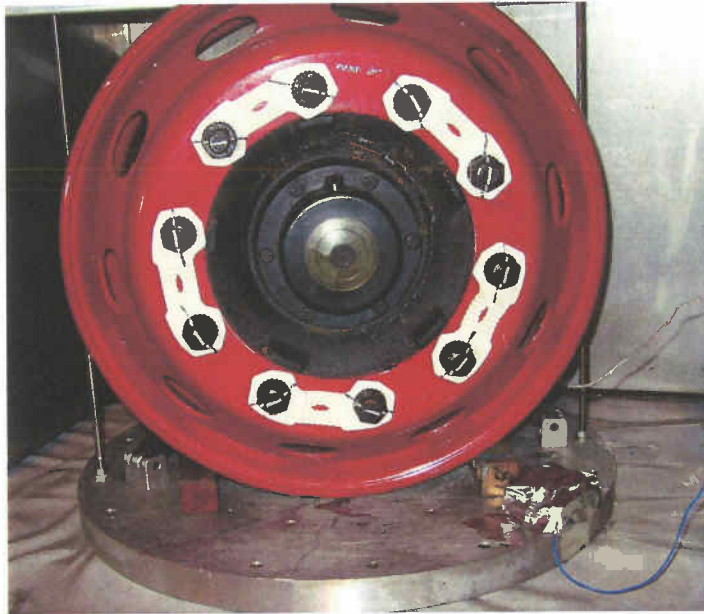
Figure 9A

The 26 in. Steel Rim after vibration testing at 120°C

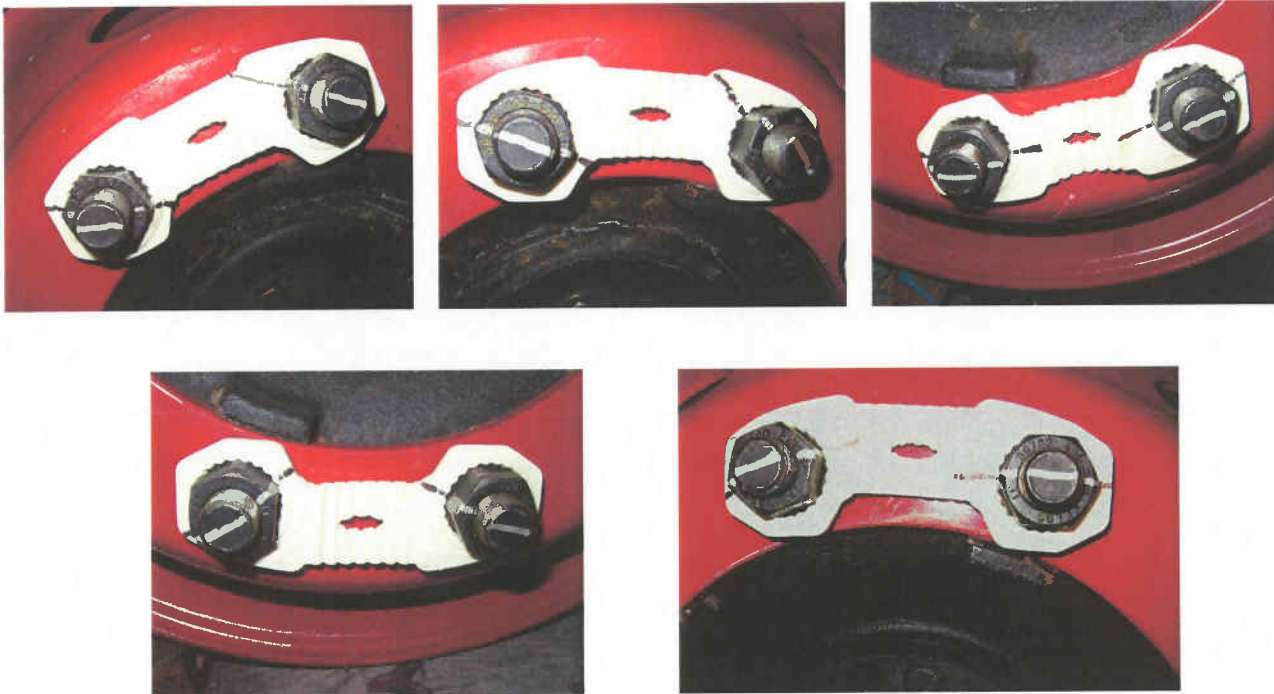
Figure 10A

The various lug nuts and Zafety Lug Lock units, indicating the position of the lug nuts after testing at 120°C

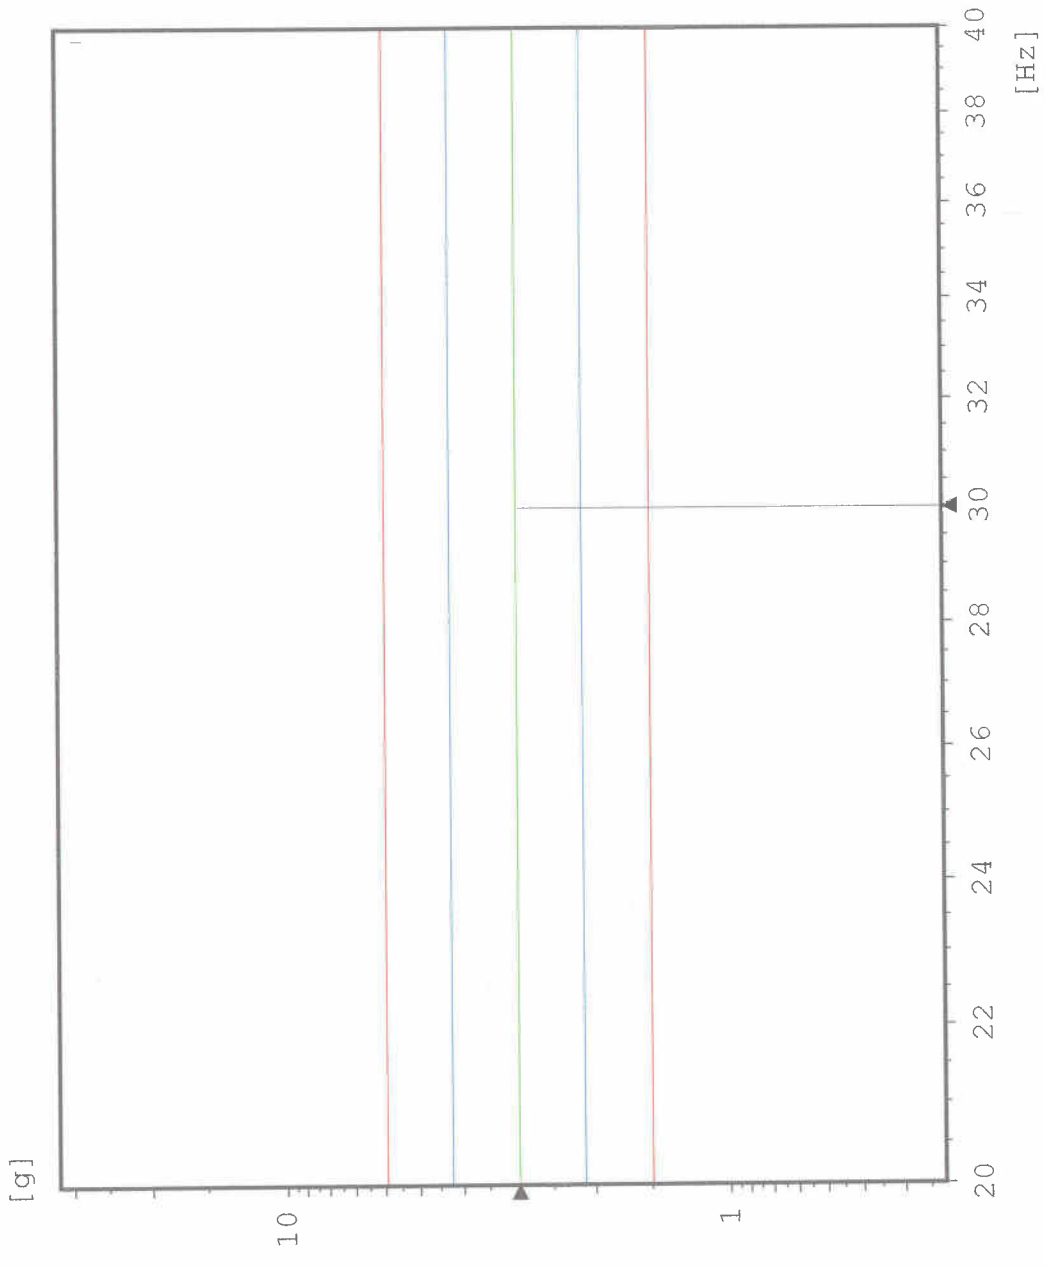
Figure 1B *[Signature]*

Sine Dwell Control channel

Vertical Direction, At -40 C

Sweep type : log
 Sweeps done : 0
 Sweeps req. : 1
 Sweep dir. : up
 Contr.strat.: Average
 Contr.mode : Closed Loop

--- Testing Time ---
 elapsed : 1:00:00
 remaining : 0:00:00

We were instructed to perform the vibration test as a sinusoidal vibration dwell at 30 Hz and 3 g acceleration amplitude at temperatures of -40°C and 120°C, employing a 60 minute dwell at each temperature. The internal chamber temperature was verified with an *OMEGA* digital thermometer.

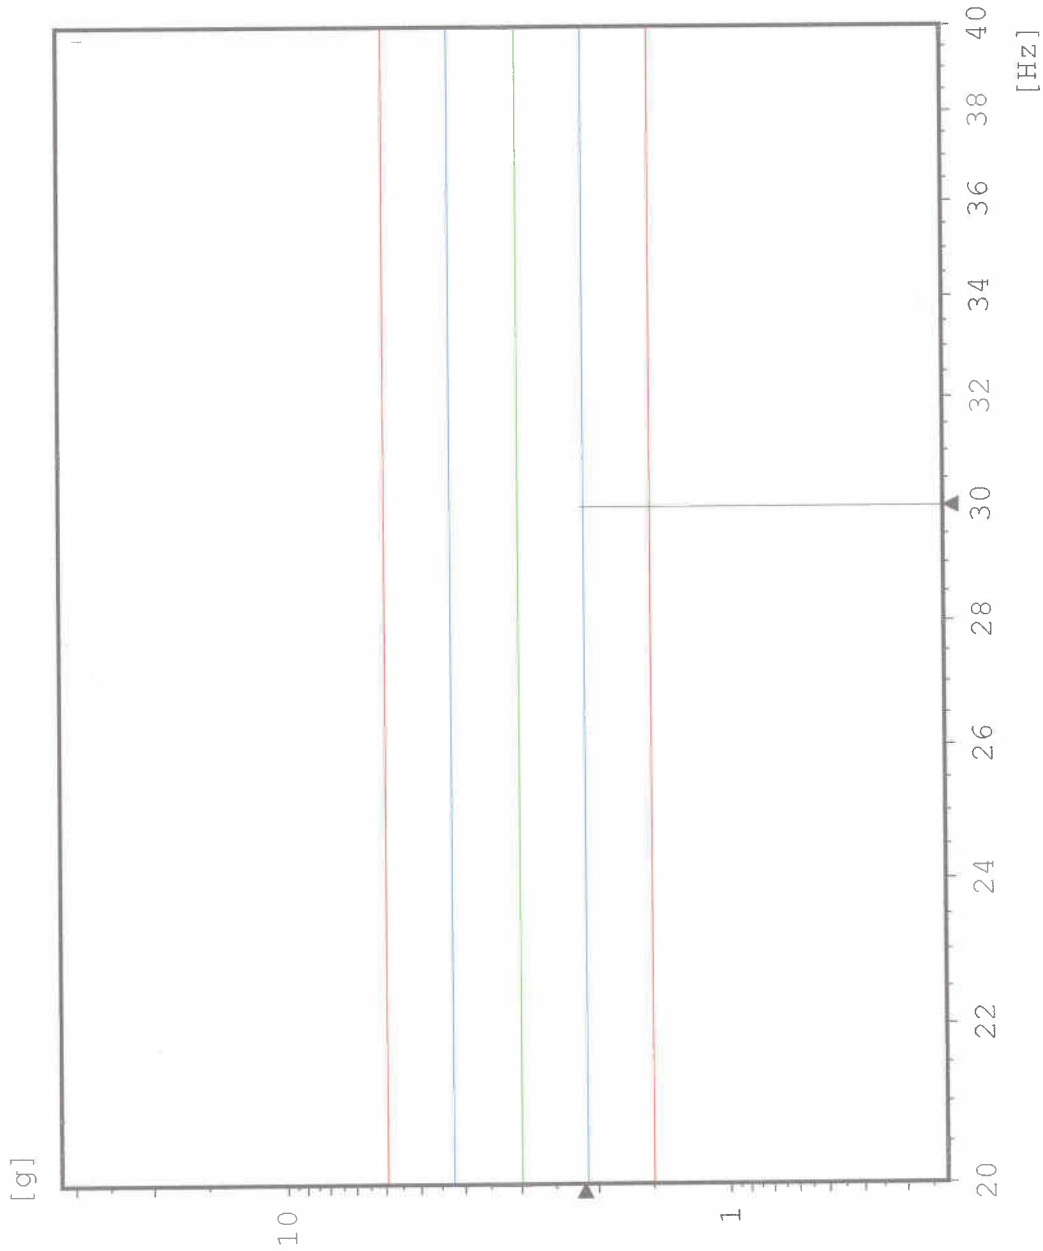
Figure 2B *Q. C.*

Sine Dwell Control channel

Vertical Direction, At 120 C

Sweep type : log
Sweeps done : 0
Sweeps req. : 1
Sweep dir. : up
Contr.strat.: Average
Contr.mode : Closed Loop

--- Testing Time ---
elapsed : 1:03:11
remaining : 0:03:11

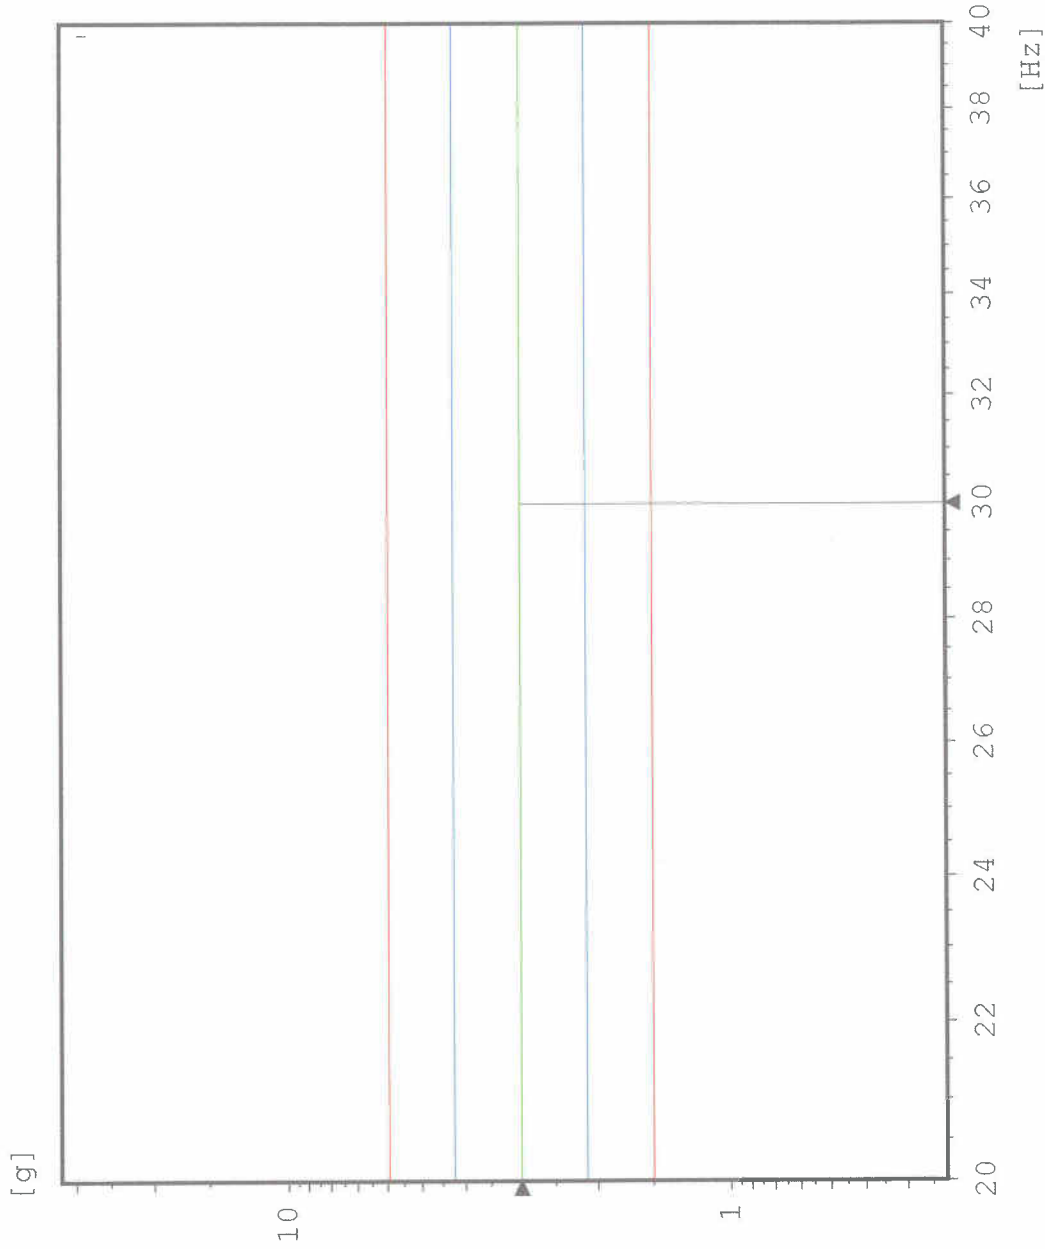
Sine Dwell Control channel

Vertical Direction, At -40 C

Sweep type : log
Sweeps done : 0
Sweeps req. : 1
Sweep dir. : up
Contr.strat.: Average
Contr.mode : Closed Loop

--- Testing Time ---
elapsed : 1:00:00
remaining : 0:00:00

Cursor: 29.99 Hz

3 g

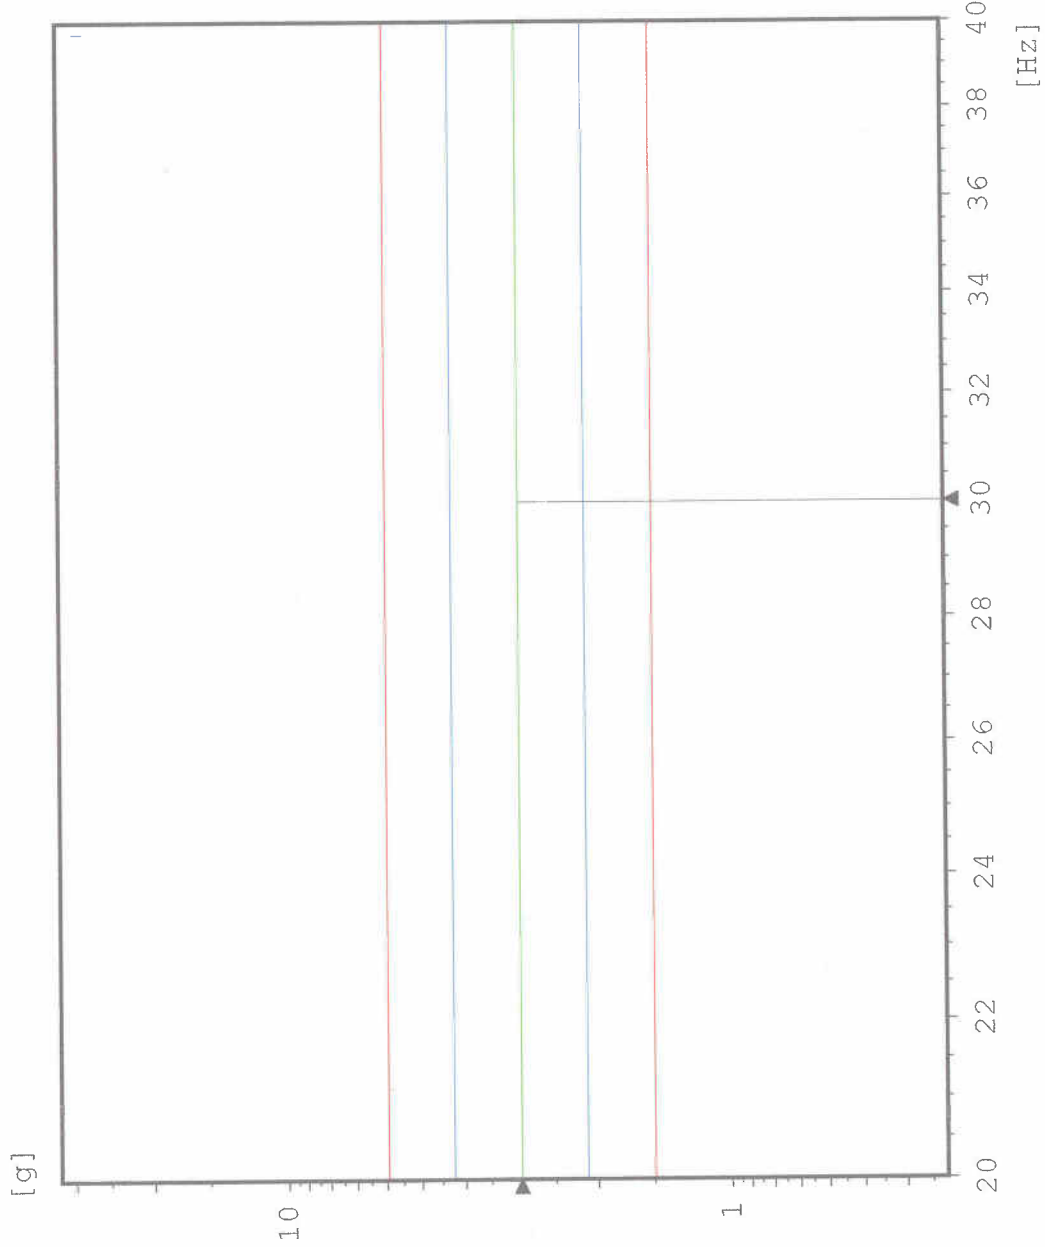
Figure 4 B *[Handwritten Signature]*

Sine Dwell Control channel

Vertical Direction, At 120 C

Sweep type : log
 Sweeps done : 1
 Sweeps req. : 1
 Sweep dir. : up
 Contr.strat.: Average
 Contr.mode : Closed Loop

--- Testing Time ---
 elapsed : 1:00:00
 remaining : 0:00:00
