Temperature & Vibration Testing on Zafety Lug Lock

A Report to: **TAFCAN Consulting Ltd.**
2107 Pinevalley Crescent
Oakville, Ontario
L6H 6L8

Report Number: 08-03-C0185
3 Pages, 1 Appendix

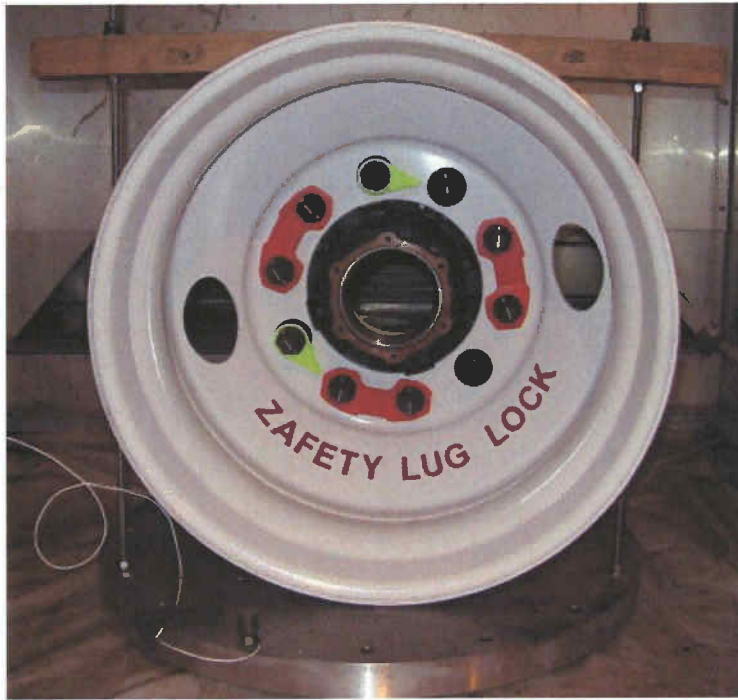
Figure 1A: Vertical vibration test set-up at 25 °C

The vibration tests were performed on the vertical table of the Thermotron DS640 vibration test system. The wheel was attached to the vibration platform with its vertical axis parallel to the vibration platform's thrust direction for vibration testing in the vertical direction (Z) as shown in Appendix A, Figure 1A and 2A.

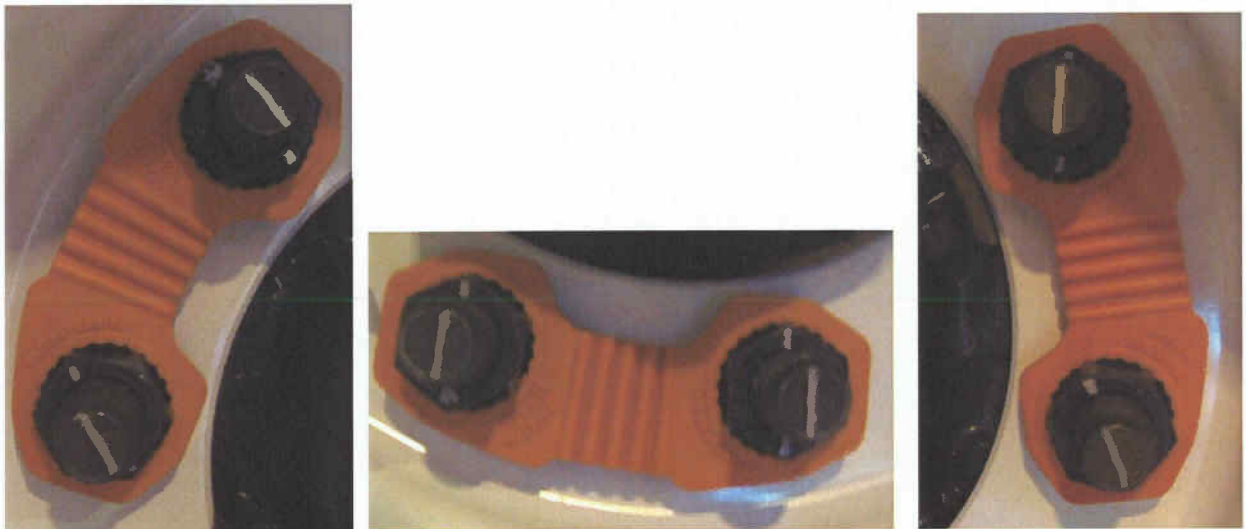
Figure 2A: Photos of Zafety Lug Lock prior to vibration test at 25 °C

The vibration test was performed in sequence listed in Table 1. On completion of the vibration testing at 25 °C, a posttest visual inspection indicated that the Zafety Lug Lock did not sustain any external damages or physical degradation and no evidence of any looseness.

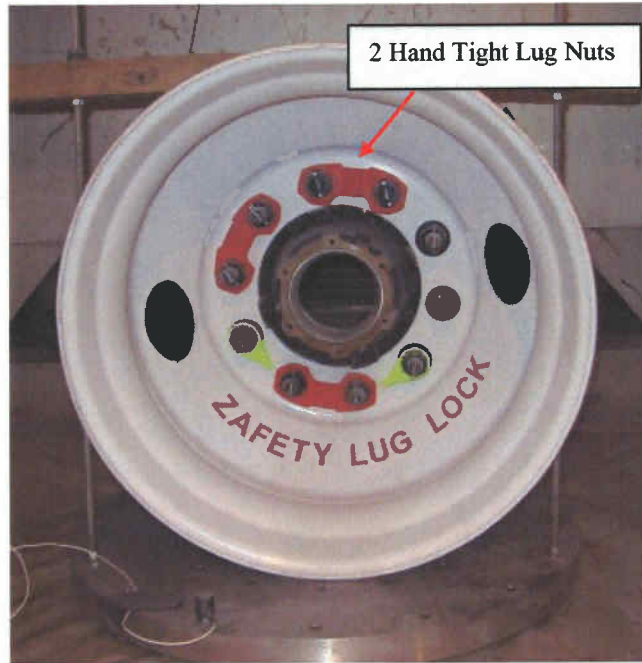
Figure 3A: Vertical vibration test set-up for 55 °C and -40 °C

Prior to the vibration test conducted at +50 °C and -40 °C, the representative installed two lug nuts with hand tight onto the top position wheel studs then inserted a Zefety Lug Lock onto them, as shown in Appendix A, Figure 3A.

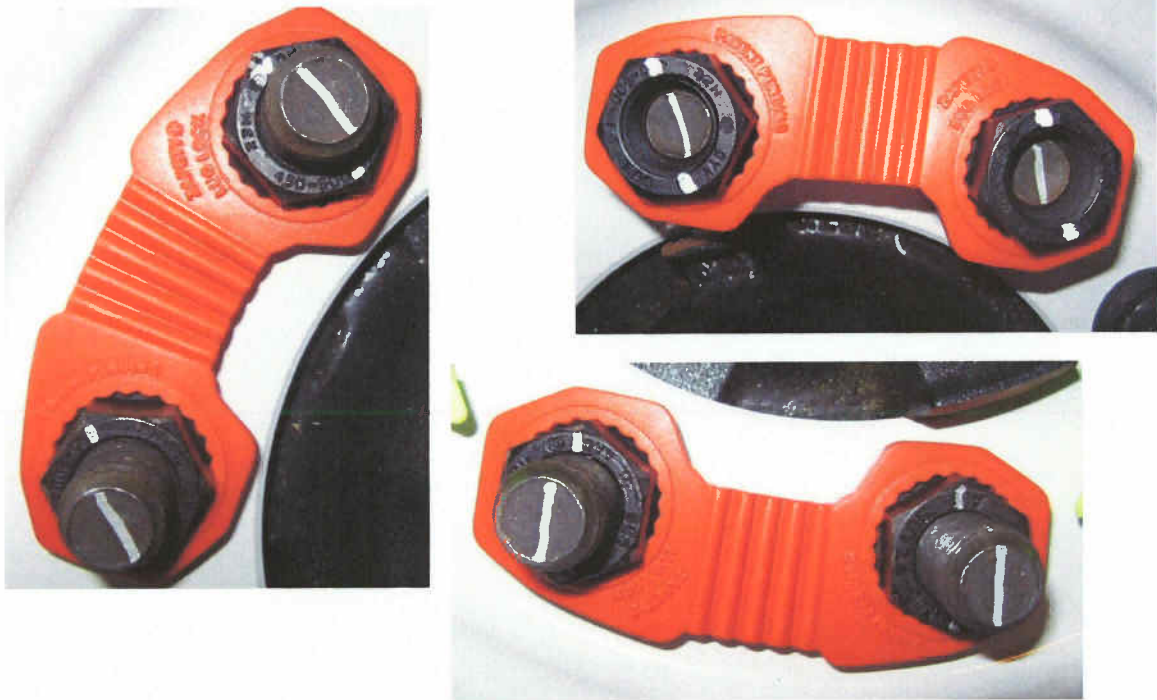
Figure 4A: Photos of Zafety Lug lock prior to vibration test at 55 °C

Again, upon completion of the vibration testing at each temperature level of +55 °C and -40 °C, a posttest visual inspection indicated that the Zafety Lug Lock did not sustain any external damages or physical degradation and no evidence of any looseness of the lug nuts.

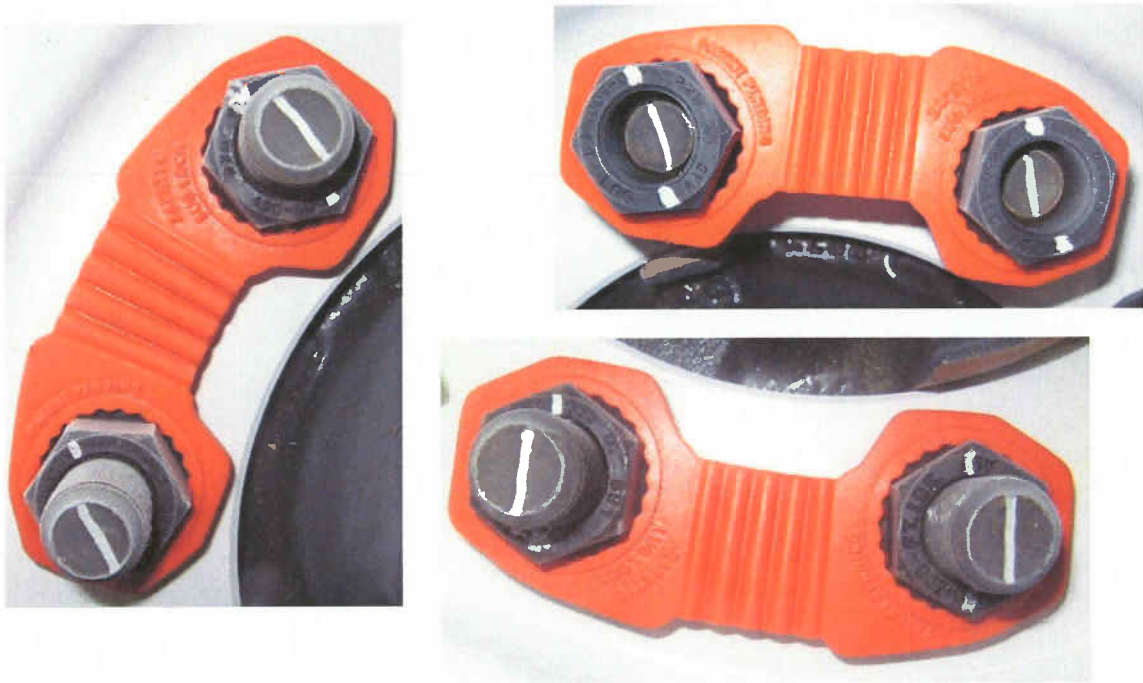
Figure 5A: Photos of Zafety Lug lock after vibration test at -40 °C
