Temperature & Vibration Testing on Zafety Lug Lock

A Report to: **TAFCAN Consulting Ltd.**
2107 Pinevalley Crescent
Oakville, Ontario
L6H 6L8

Report Number: 08-03-C0185
3 Pages, 1 Appendix

Date: July 10, 2008

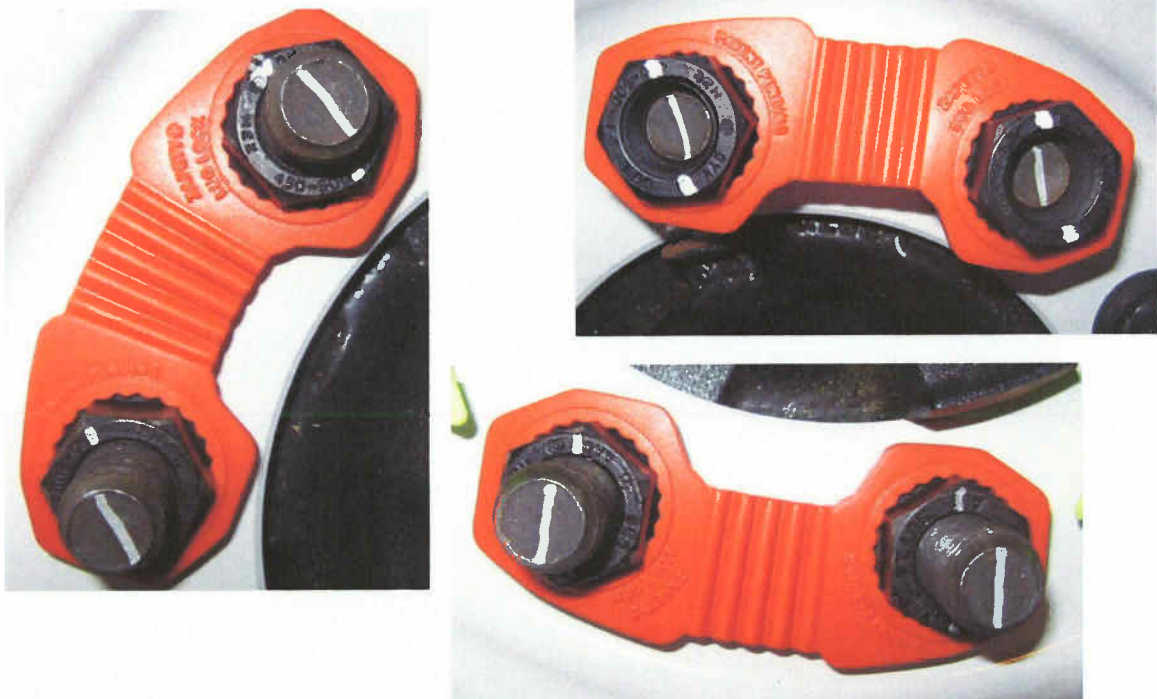
Figure 4A: Photos of Zafety Lug lock prior to vibration test at 55 °C

Again, upon completion of the vibration testing at each temperature level of +55 °C and -40 °C, a posttest visual inspection indicated that the Zafety Lug Lock did not sustain any external damages or physical degradation and no evidence of any looseness of the lug nuts.

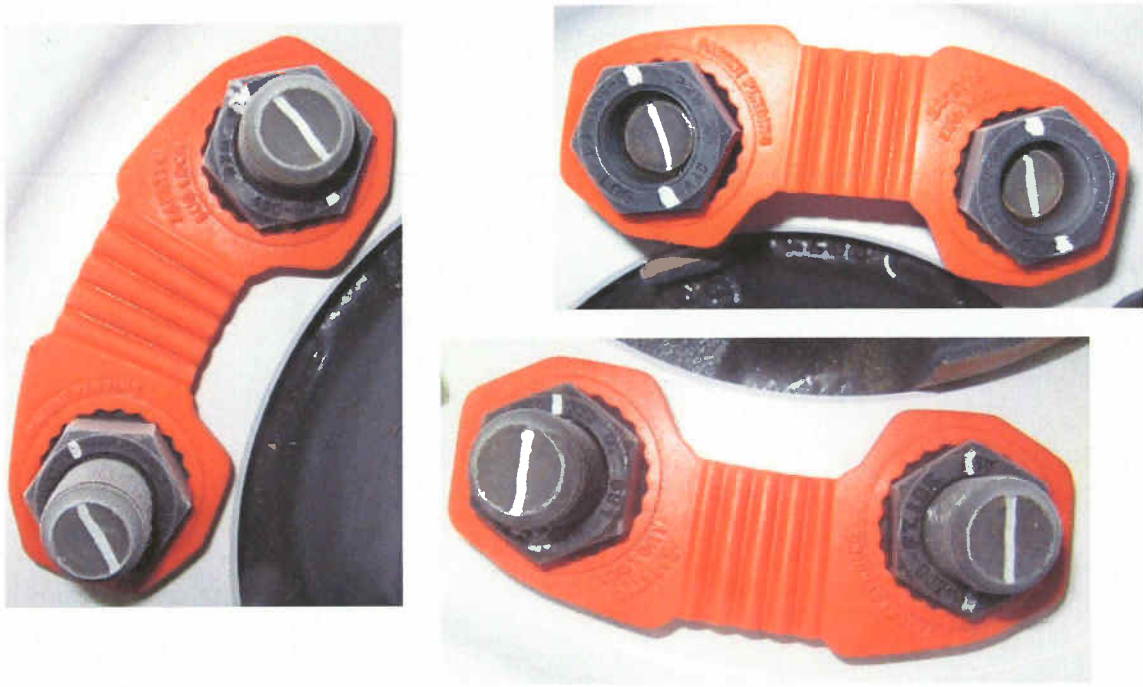
Figure 5A: Photos of Zafety Lug lock after vibration test at -40 °C
